# **2017 PROPERTY CONDITION ASSESSMENT REPORT – Volume I – Terminal Site - FINAL**

## **Buffalo Outer Harbor Access and Activation Civic Improvement Project**

901 Fuhrmann Blvd, Buffalo, NY 14203

**August, 2017**

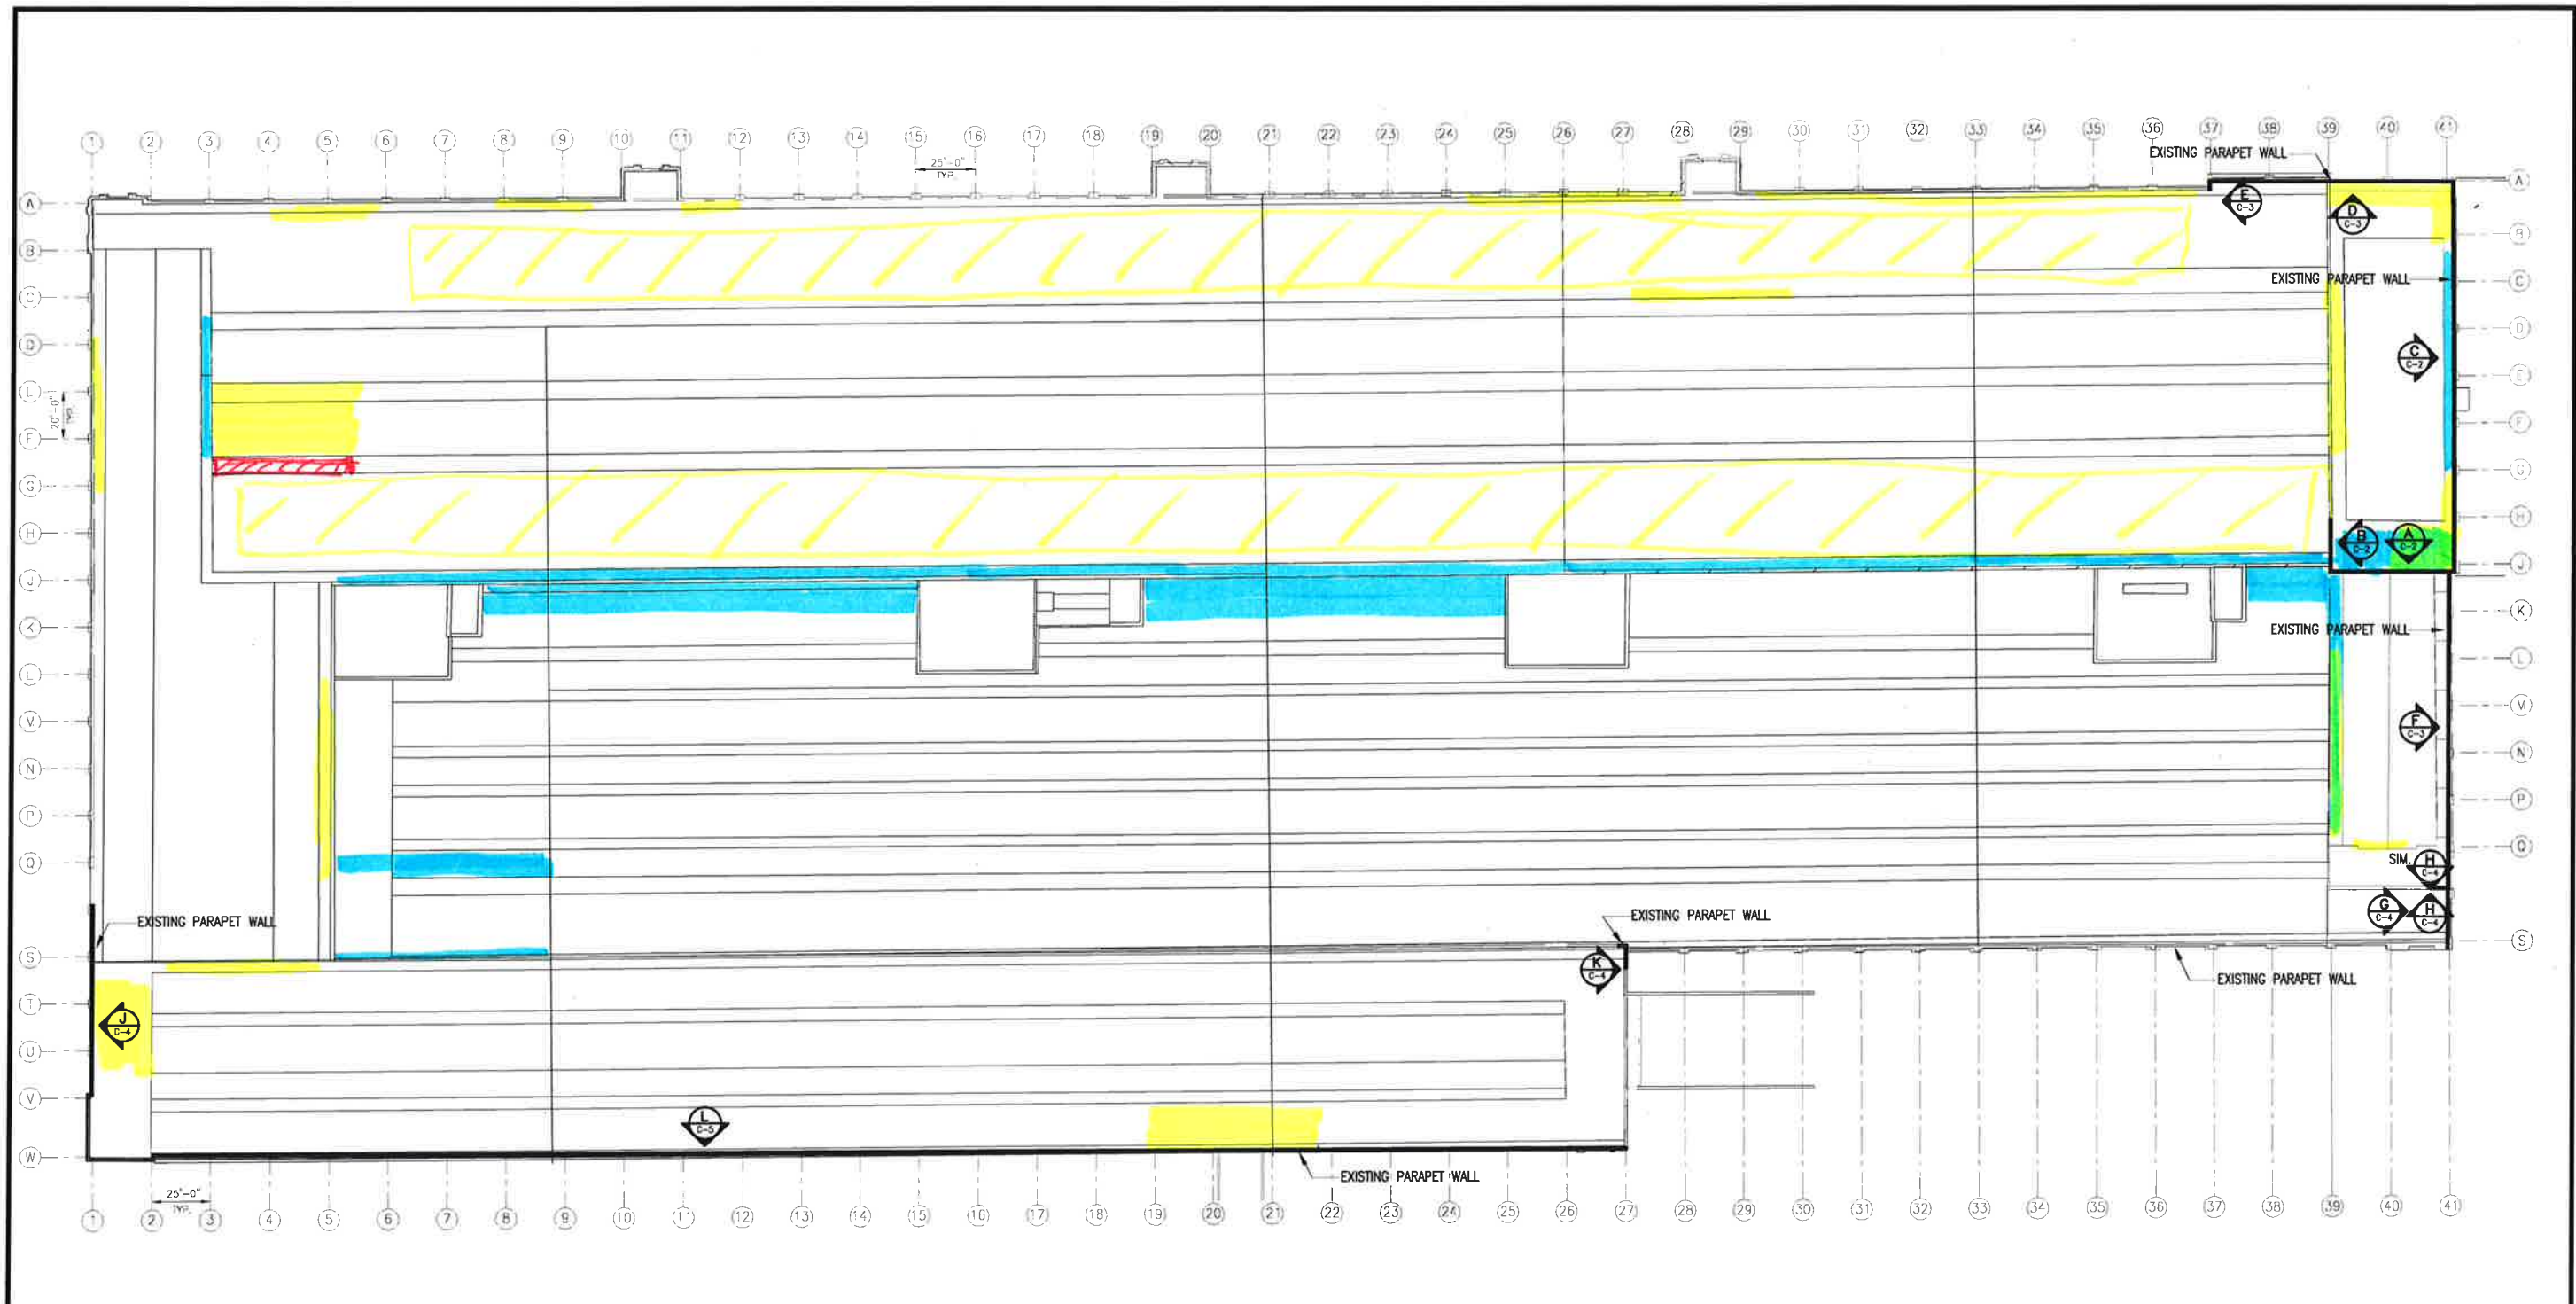
**ROOF PLAN**  
SCALE: 1/32"=1'-0"

- DAMAGED MEMBRANE
- STANDING WATER/CLOGGED ROOF DRAINS
- BLOCK IN WINDOWS

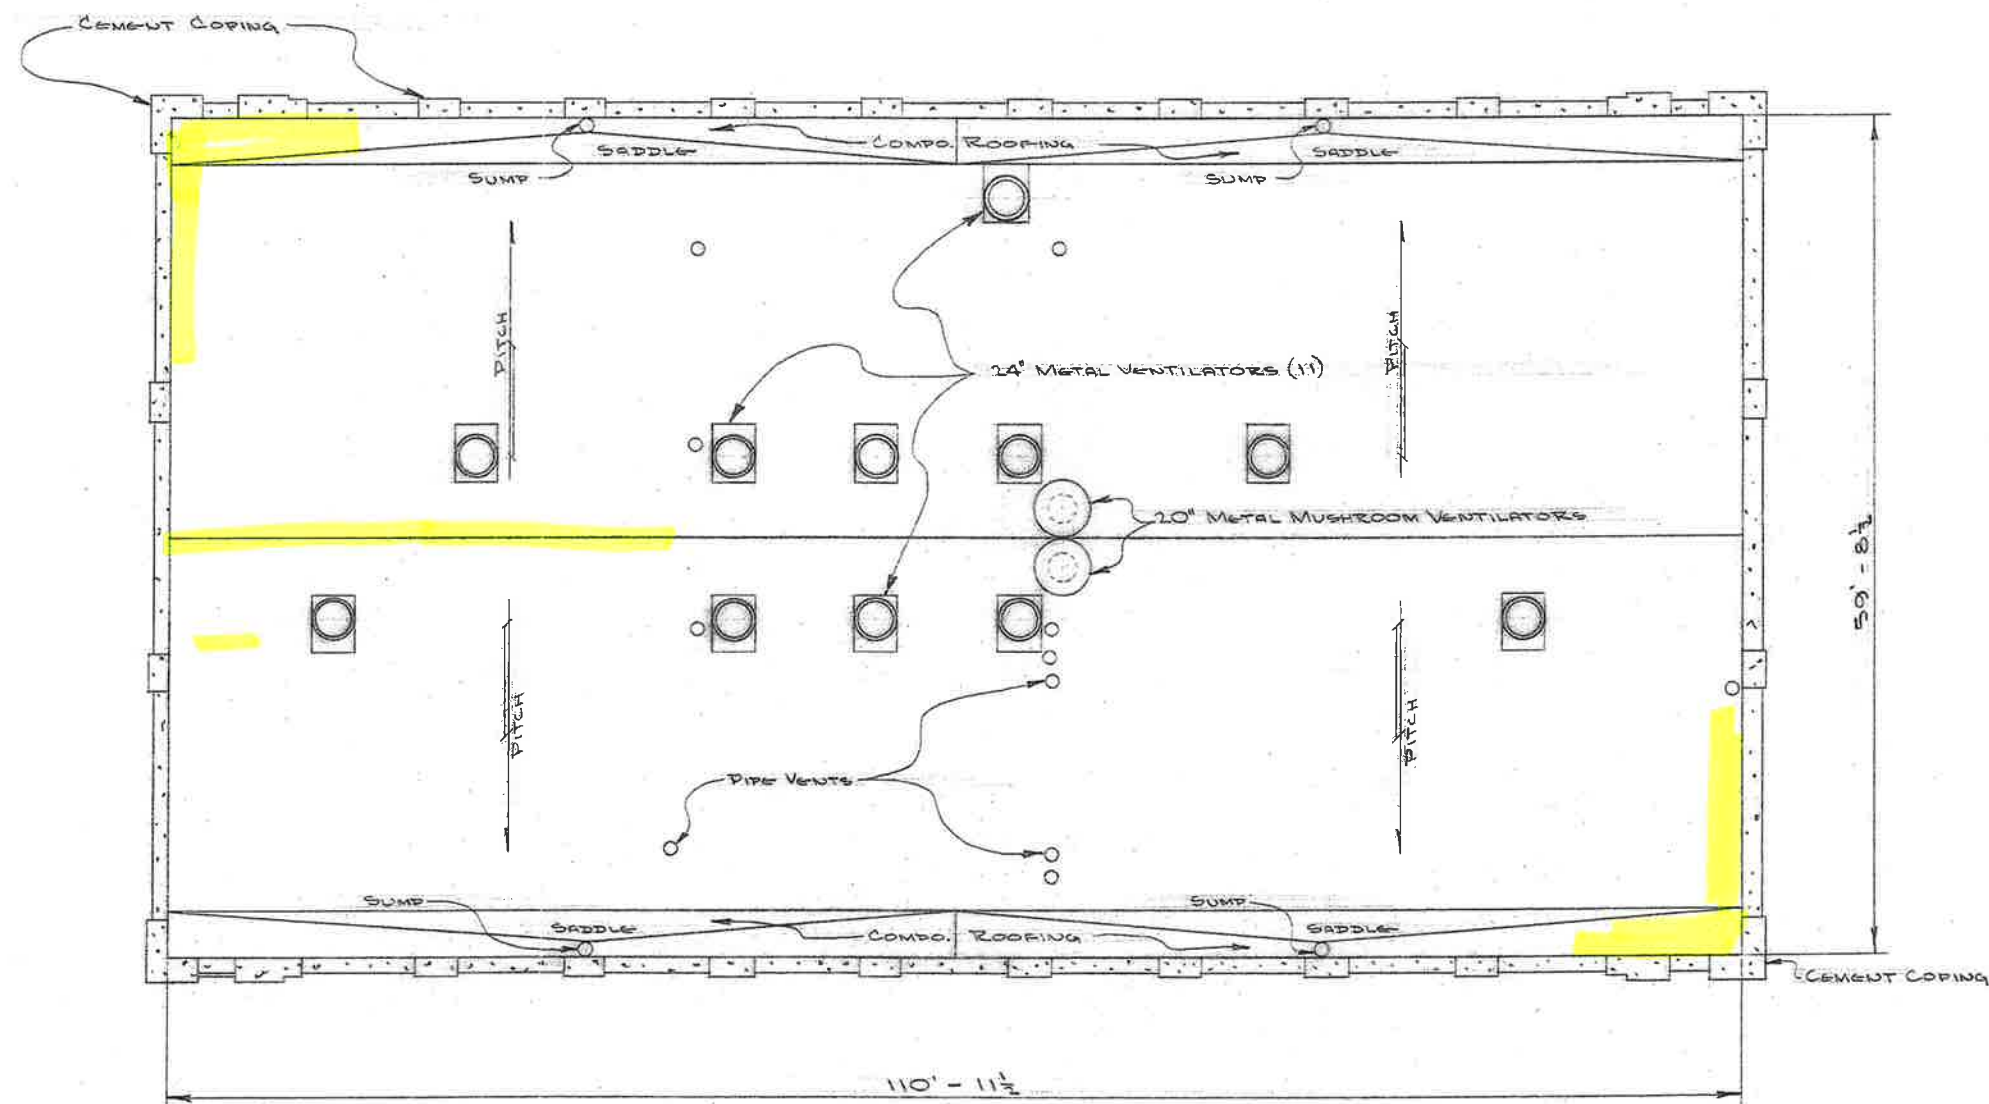
- DAMAGED MEMBRANE

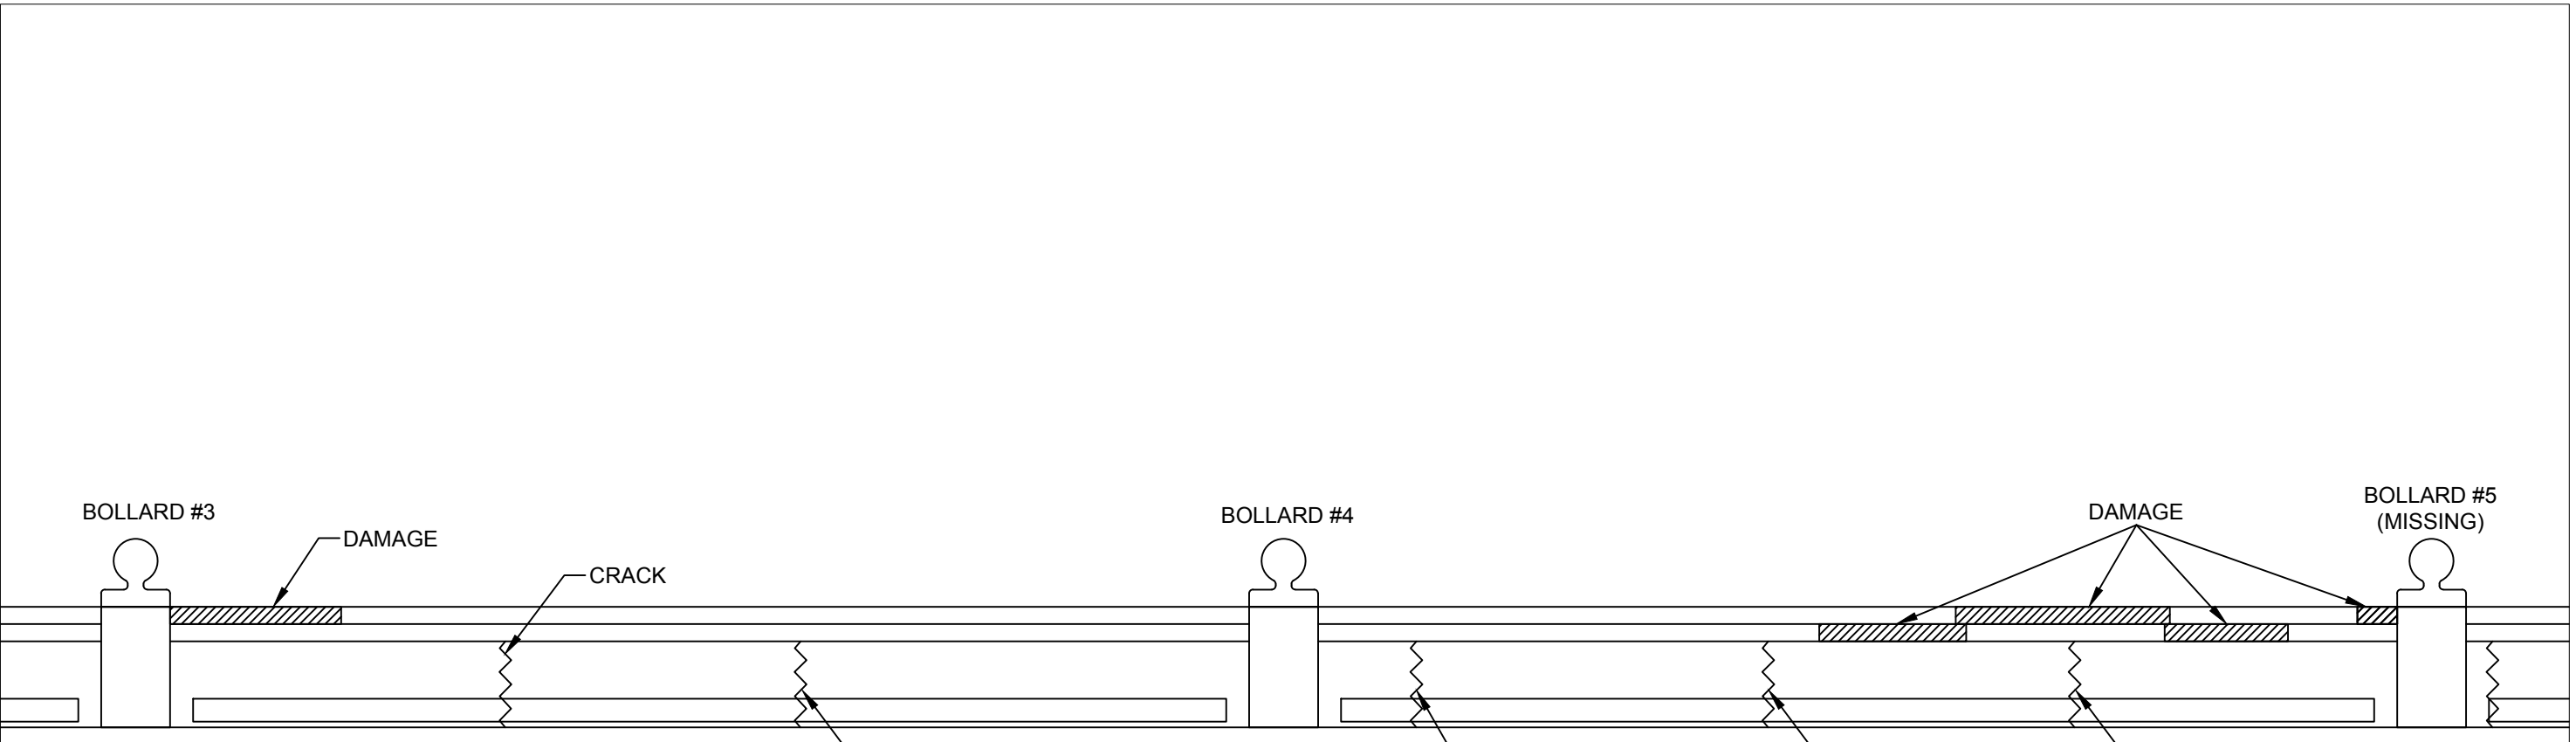
CRACK WITH A HOLE  
35' FROM #3

CRACK AND SPALLING  
5' FROM #4

CRACK

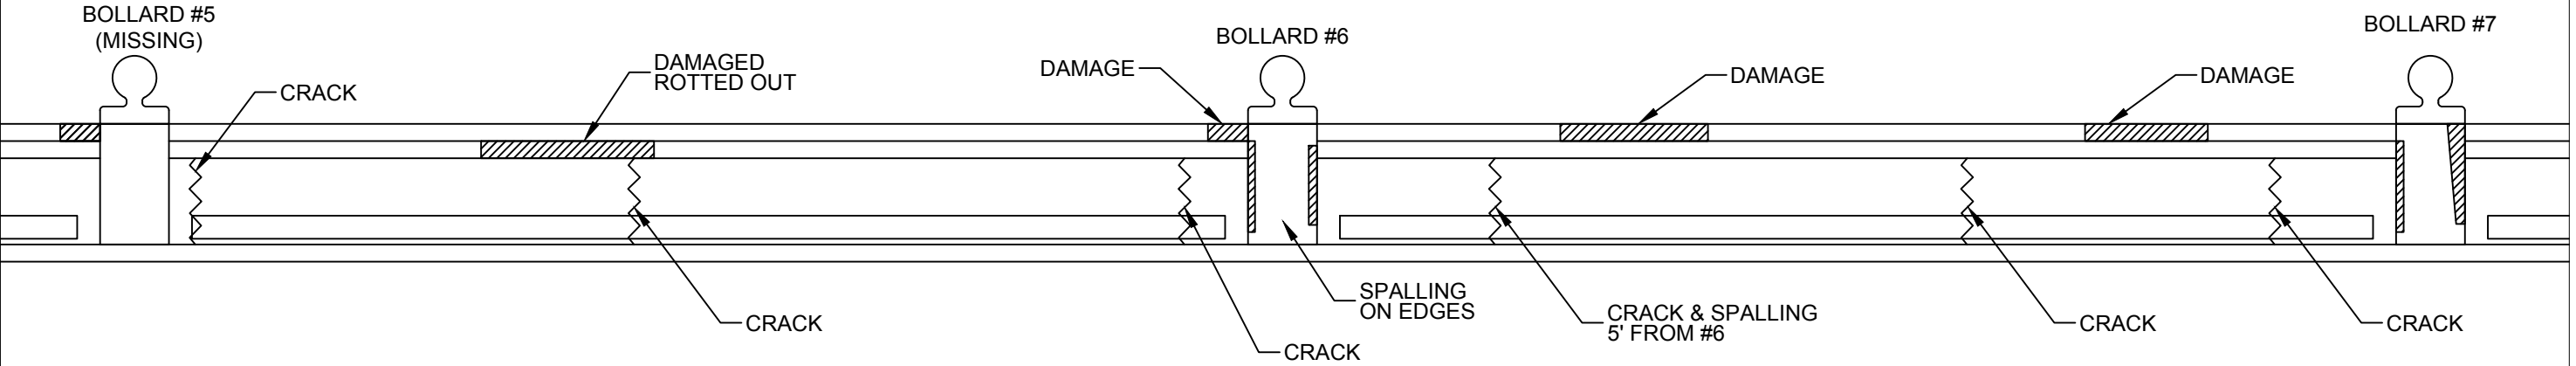
NOTE:  
STEEL BUMPERS ARE IN  
GOOD CONDITON

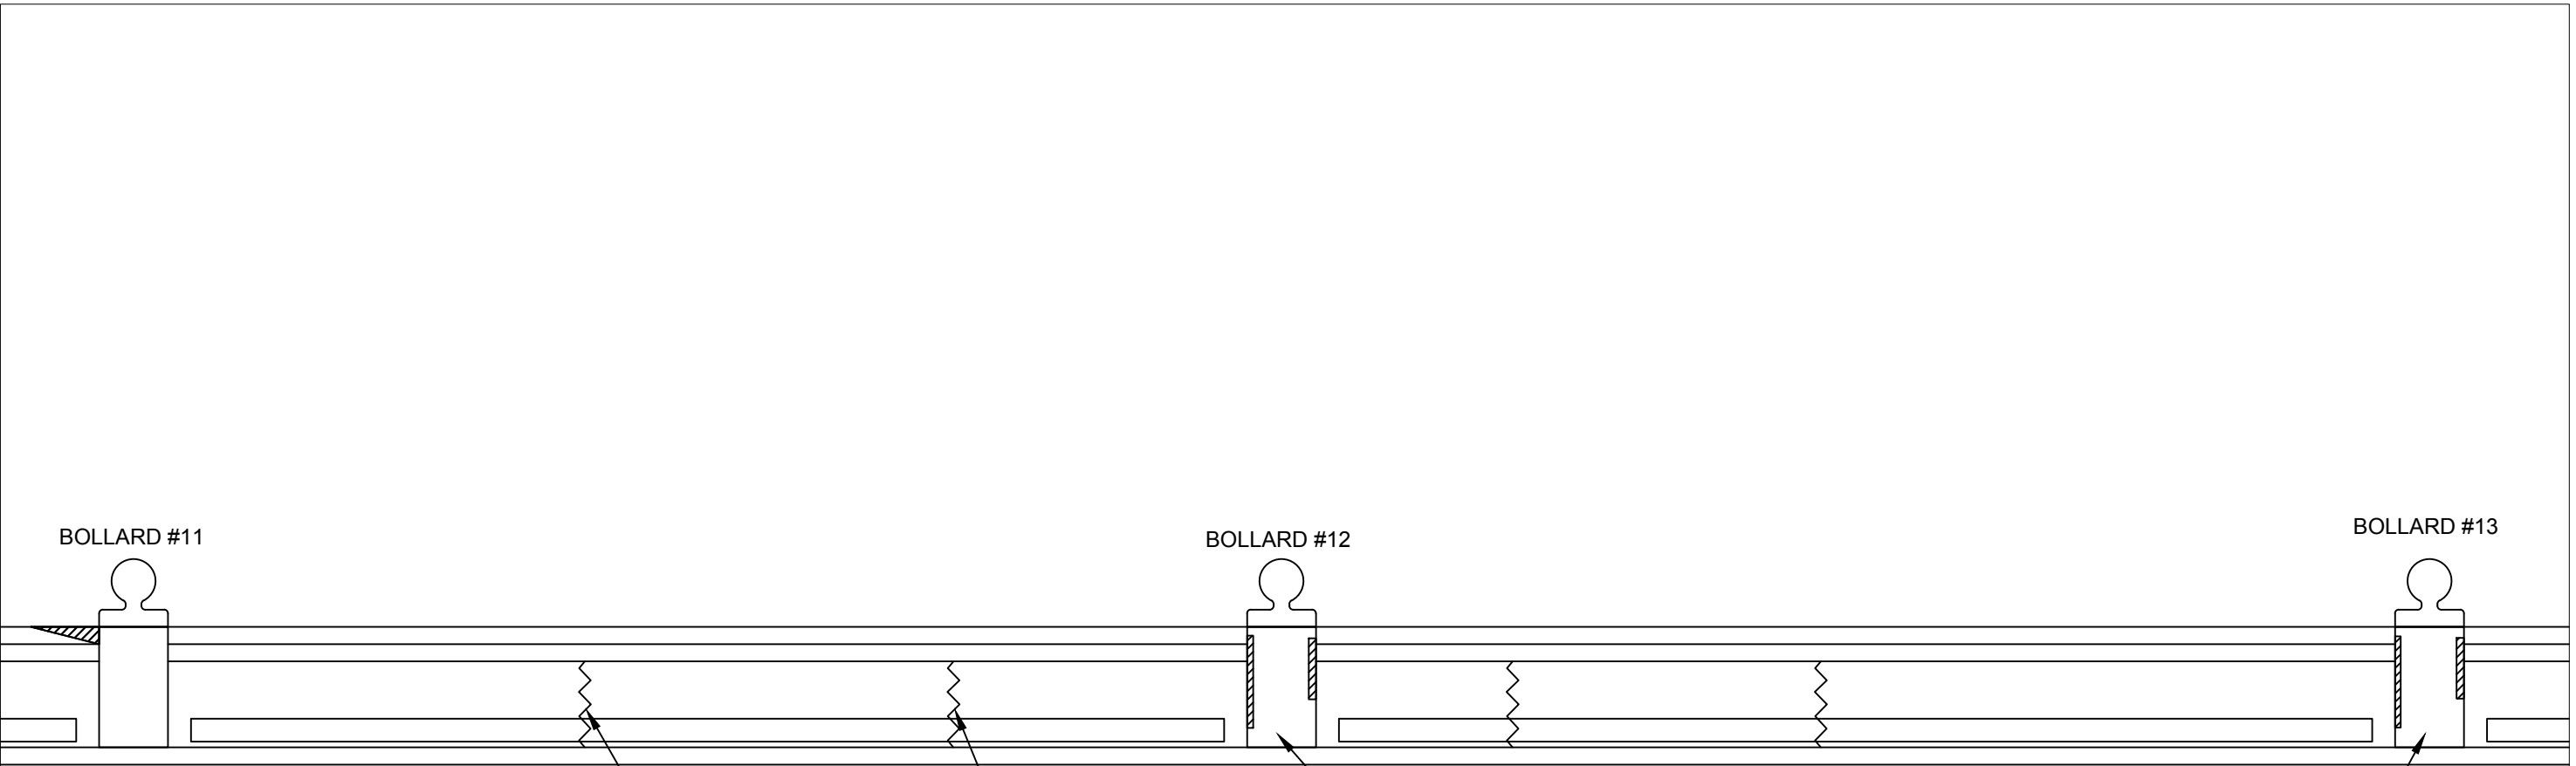
CRACK

CRACK WITH SPALLING  
10' FROM #12

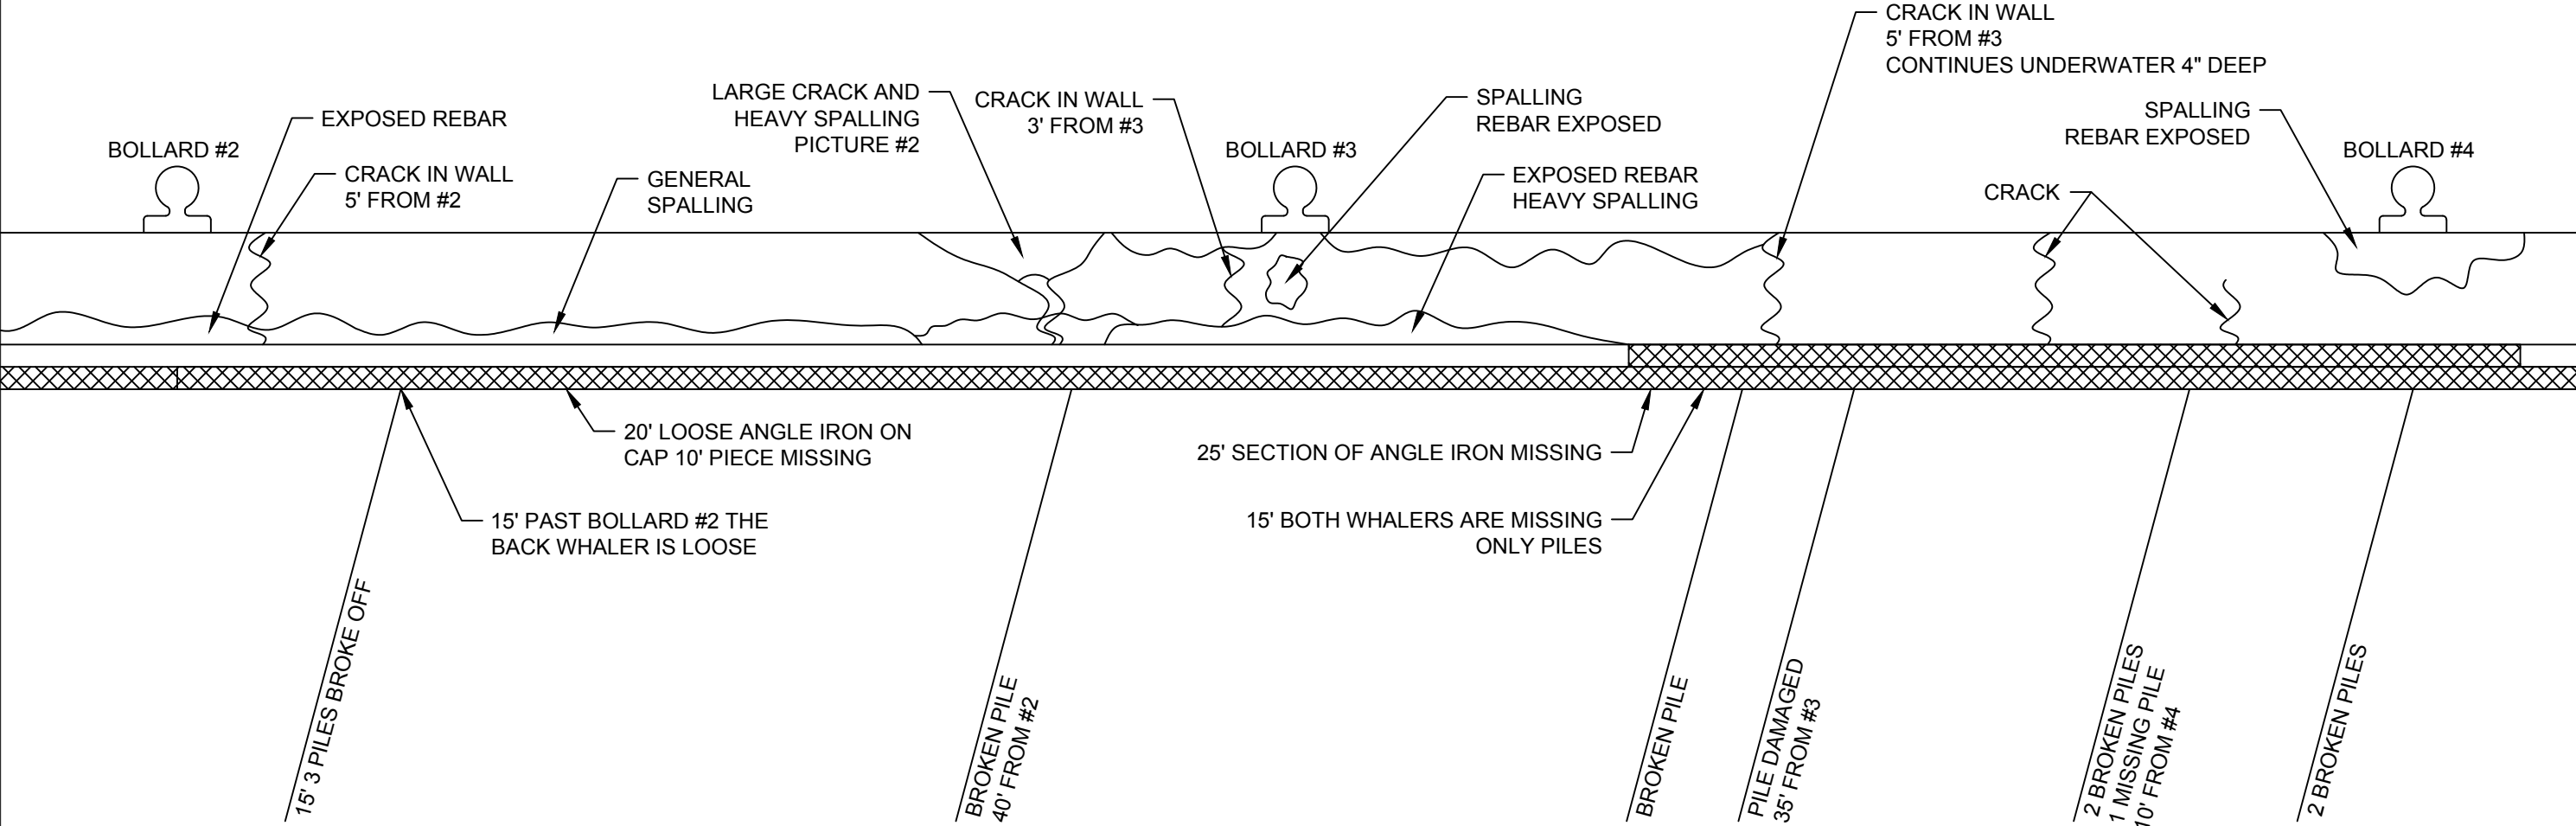
NOTE:  
- THERE IS A 4x4 ANGLE IRON RUNNING THE LENGTH OF THE WALL ON THE BOTTOM CAP. MOST OF THIS ANGLE IRON IS MISSING. WHAT IS LEFT IS NOT IN GOOD CONDITION.

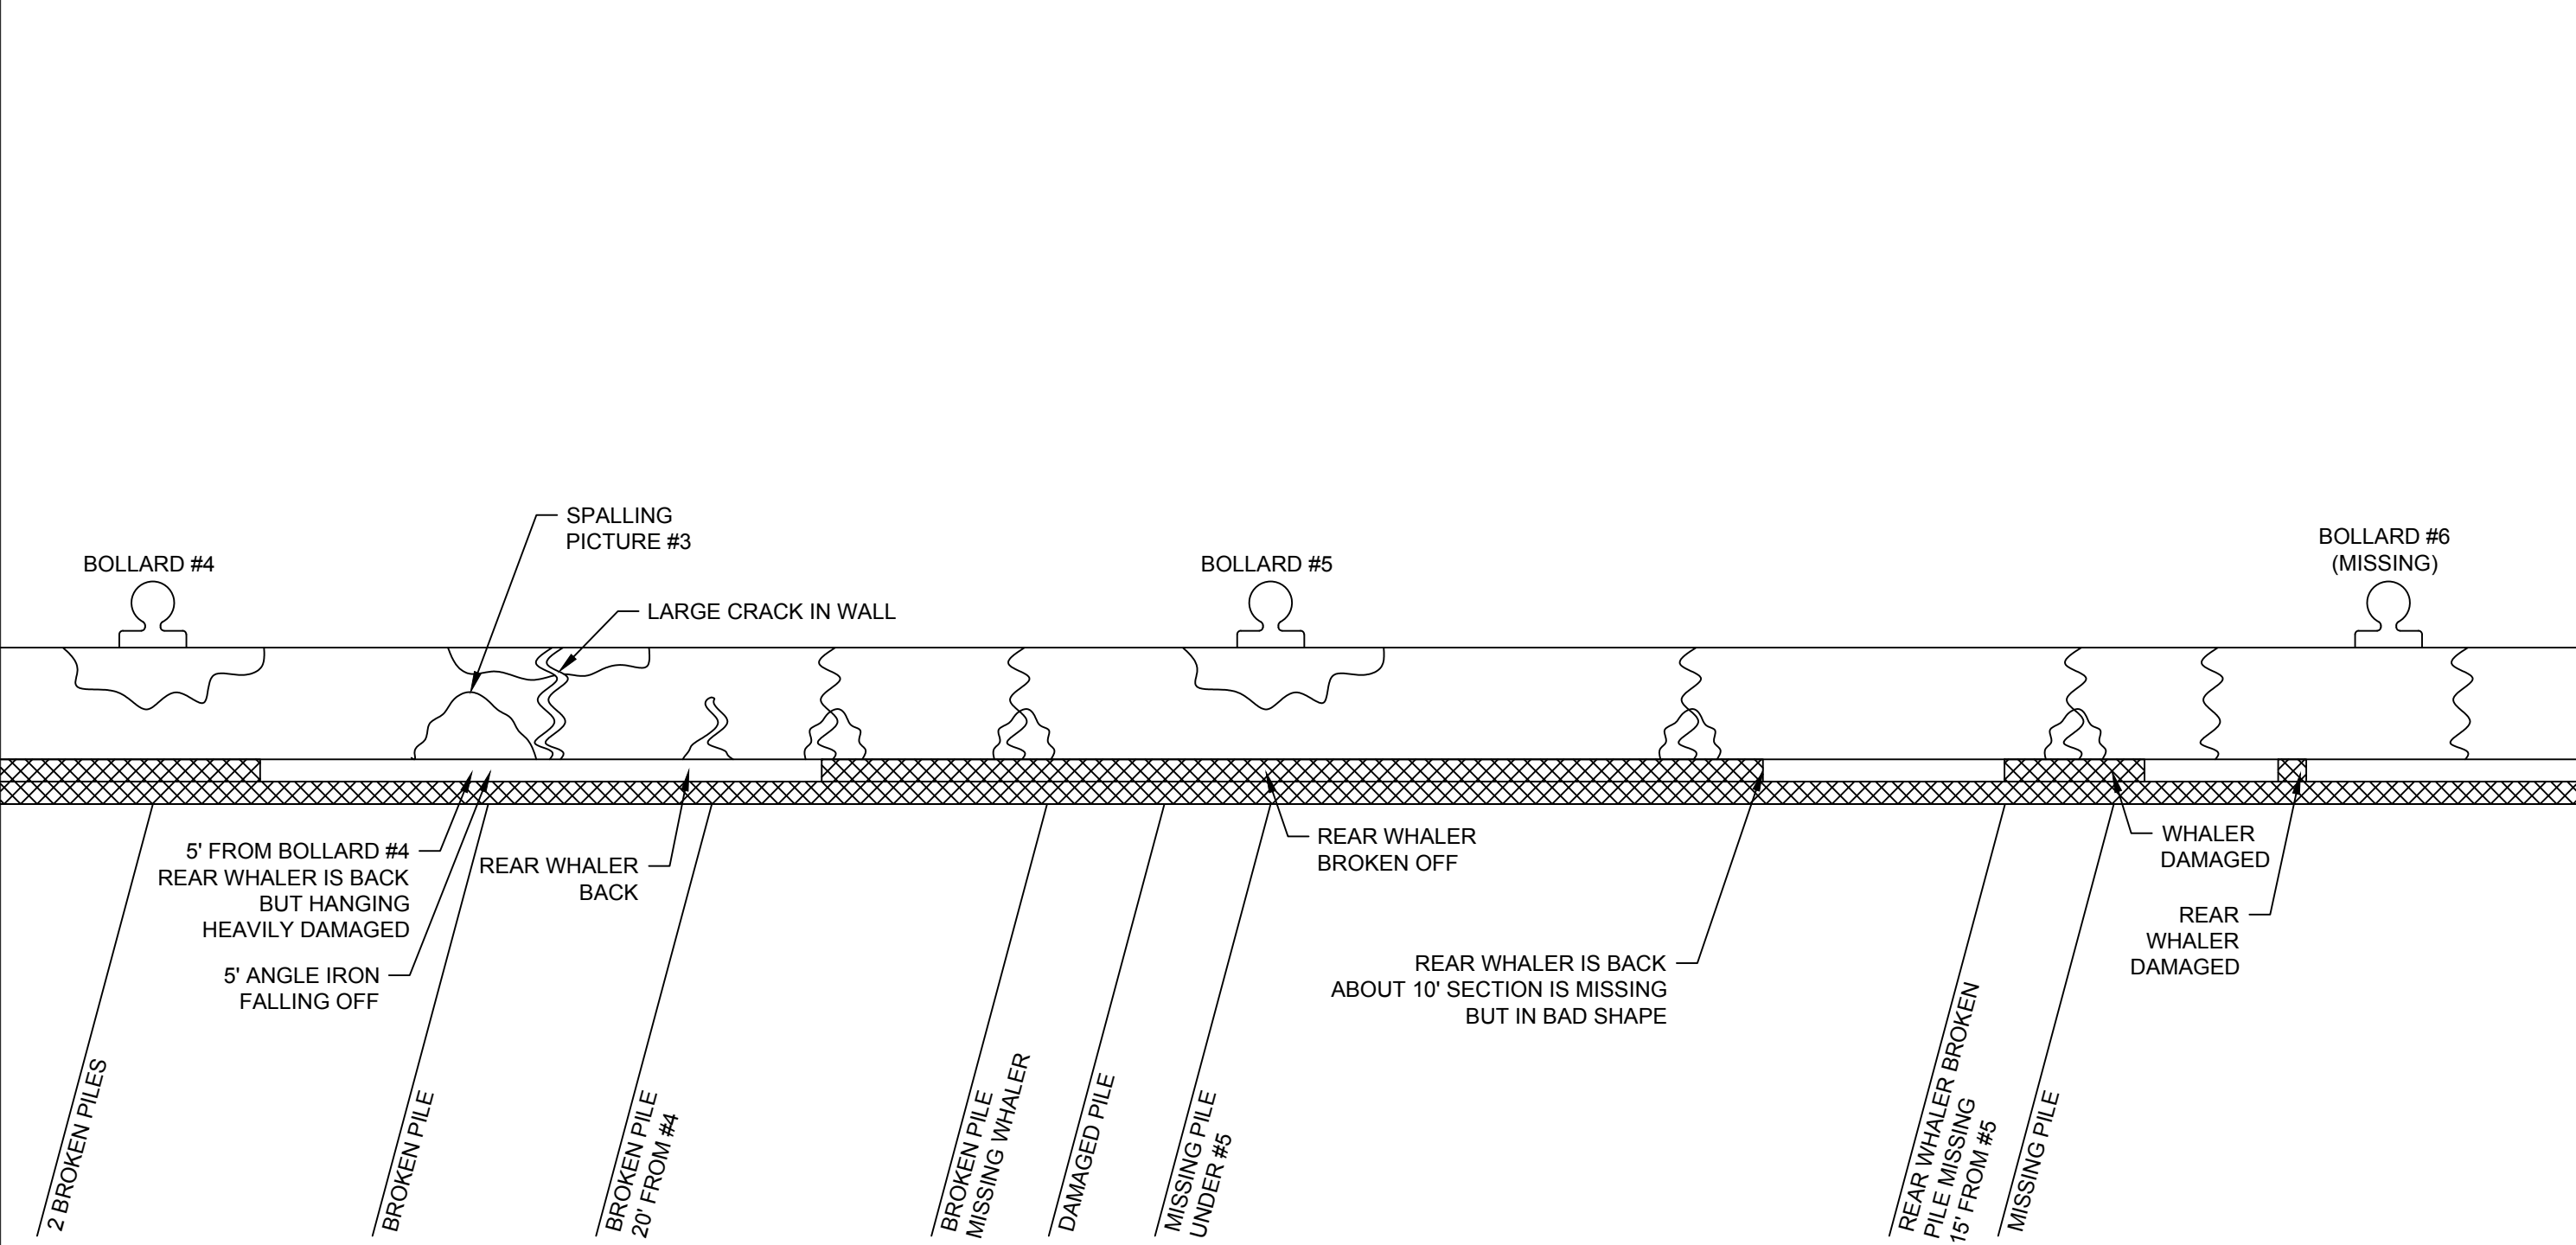
NOTE:  
- IN GENERAL, THERE ARE PILES EVERY 6'.  
- SHEET PILE WALL IN GOOD CONDITION WITH 1" TO 2" OF ZEBRA MUSSELS.
